# Monitoring Techniques for the X-29A Aircraft's High-Speed Rotating Power Takeoff Shaft

David F. Voracek

December 1990

David F. Voracek  
Ames Research Center, Dryden Flight Research Facility, Edwards, California

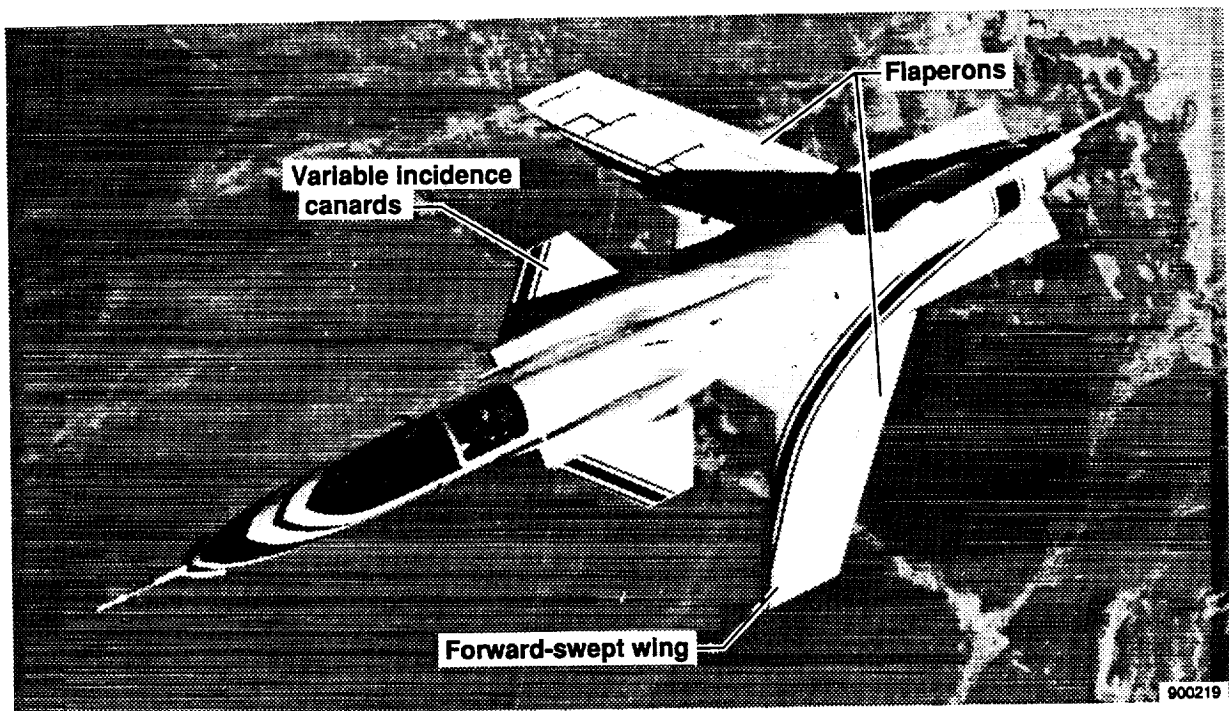
Figure 1. The X-29A forward-swept-wing aircraft.

The X-29A aircraft (fig. 1) incorporates many new technologies, the most evident of which is the forward-swept wing. The wing employs aeroelastic tailoring of advanced composite wing skins designed to avoid structural divergence and to ensure structural integrity within the flight envelope. Double-hinged trailing-edge flaperons provide both aerodynamic camber and roll control. The variable incidence canards, along with the wings and flaperons, operate together to achieve minimum trim drag. The vehicle is unstable longitudinally, with a negative static margin of 35 percent of the mean aerodynamic chord at subsonic speeds, and it is neutrally stable at approximately Mach 1.4. The flight control system includes triply redundant digital computers that provide the information to safely fly the aircraft.

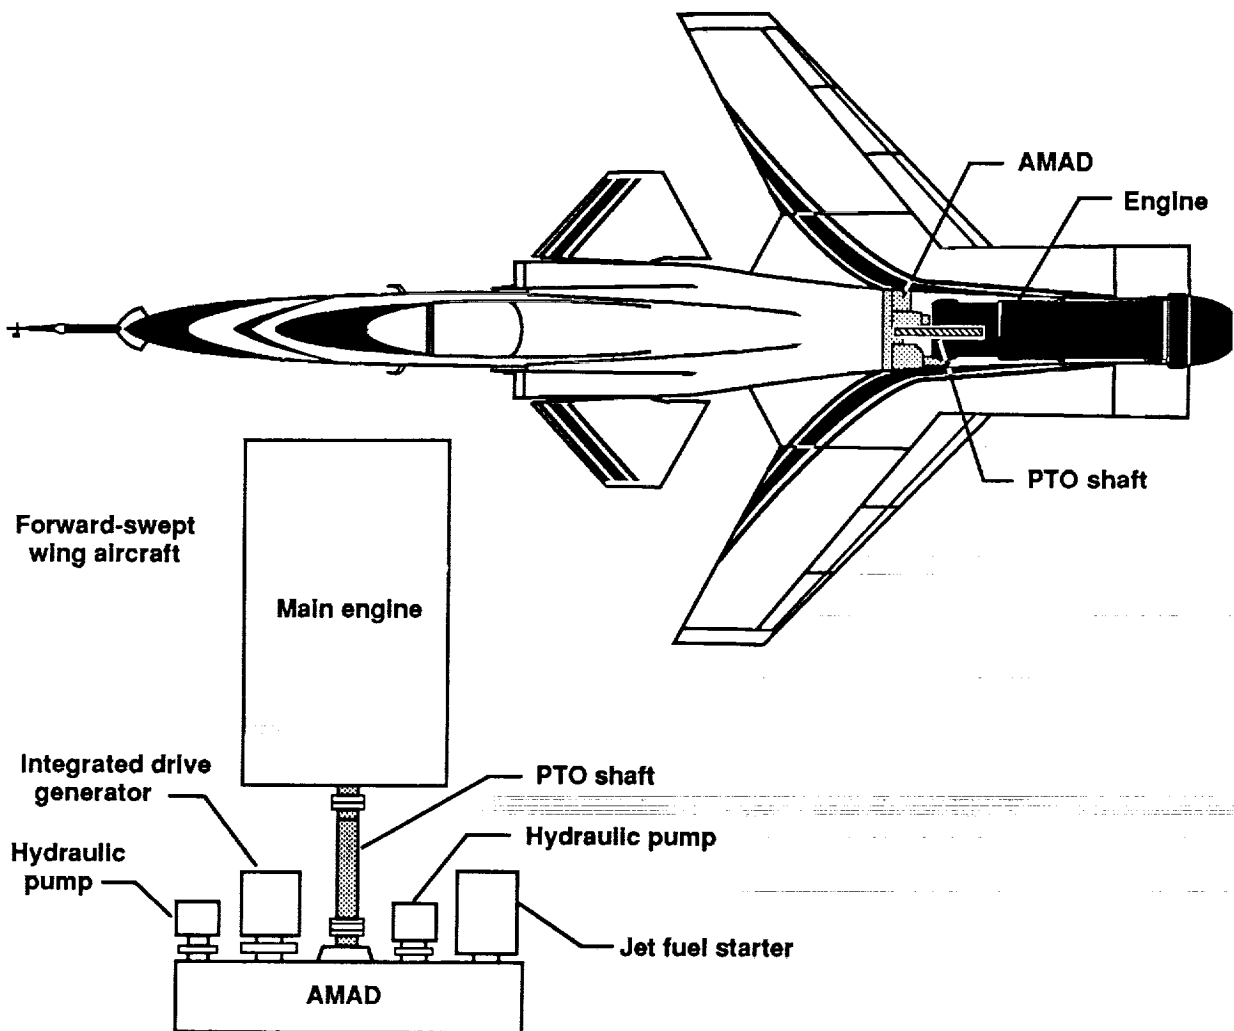
Figure 2. PTO shaft and AMAD.

The engine starting and secondary power subsystems incorporate the engine start system and the PTO shaft. The engine start system consists of a jet fuel starter system and an AMAD. Figure 2 shows an enlargement of the mounted accessories of the AMAD which consist of a starter, two hydraulic pumps, and an integrated drive generator. The PTO shaft is the direct mechanical link between the engine and the AMAD as shown in figure 2.

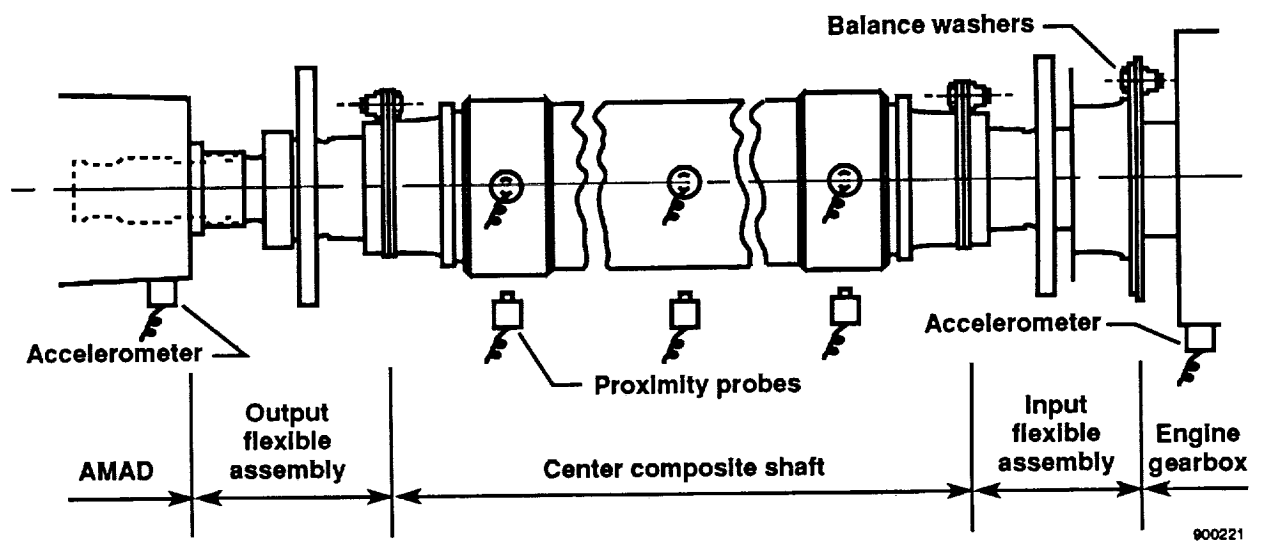
Figure 3. PTO shaft subsystem.

The PTO shaft subsystem consists of the following five subassemblies (fig. 3):

The first section, the AMAD, powers the two hydraulic pumps and the integrated drive generator, which supplies aircraft hydraulic and electrical power. The second and fourth sections, the output and input flexible assemblies, are designed to absorb any axial loads that the shaft may experience. They also provide a centering ball design which prevents the shaft from "whipping" in case of failure.<sup>(2)</sup> The third section, the center composite shaft, transmits the rotary power between the AMAD and the main engine in two modes. In the first mode, the engine starting-motoring mode, power is transmitted through the AMAD to the main engine gearbox which is geared to the main engine high-pressure compressor spool. In the second mode, the accessory drive mode, power is transmitted from the main engine gearbox to the AMAD to drive the AMAD-mounted accessories.

The high rotational speeds between 0 and 16,810 rpm of the X-29A PTO shaft require a high degree of dynamic balance between its subassemblies to prevent destructive vibrations and harmonics. The gearbox, AMAD, and composite shaft components of the assembly are balanced dynamically as a unit during manufacturing. The following table shows the balanced component matrix for two AMADs, three PTO shafts, and three engine gearboxes. Washers were used to balance the PTO subsystem and were mounted under the bolts connecting the engine gearbox to the input flexible assembly as shown in figure 3.

The ground and flight limits established by the engine and airframe manufacturers were based on the allowable limit radial loads for the engine gearbox duplex bearings. Initial engine ground runs were accomplished with the PTO shaft instrumented with proximity probes (fig. 3) to establish a relationship between the shaft deflection and the engine bearing loads. This relationship was established because the accelerometer used for flight and ground monitoring was located on the engine gearbox assembly. The AMAD limits were developed in a similar procedure also based on the gearbox duplex bearing loads. The recommended acceleration limits, which were established by analysis and ground testing for the gearbox, consist of 2.7 *g* at 80 percent (227 Hz) of the engine speed during the engine ground runs and a 6.0-*g* limit during flight. The limits for the AMAD are shown in figure 5.

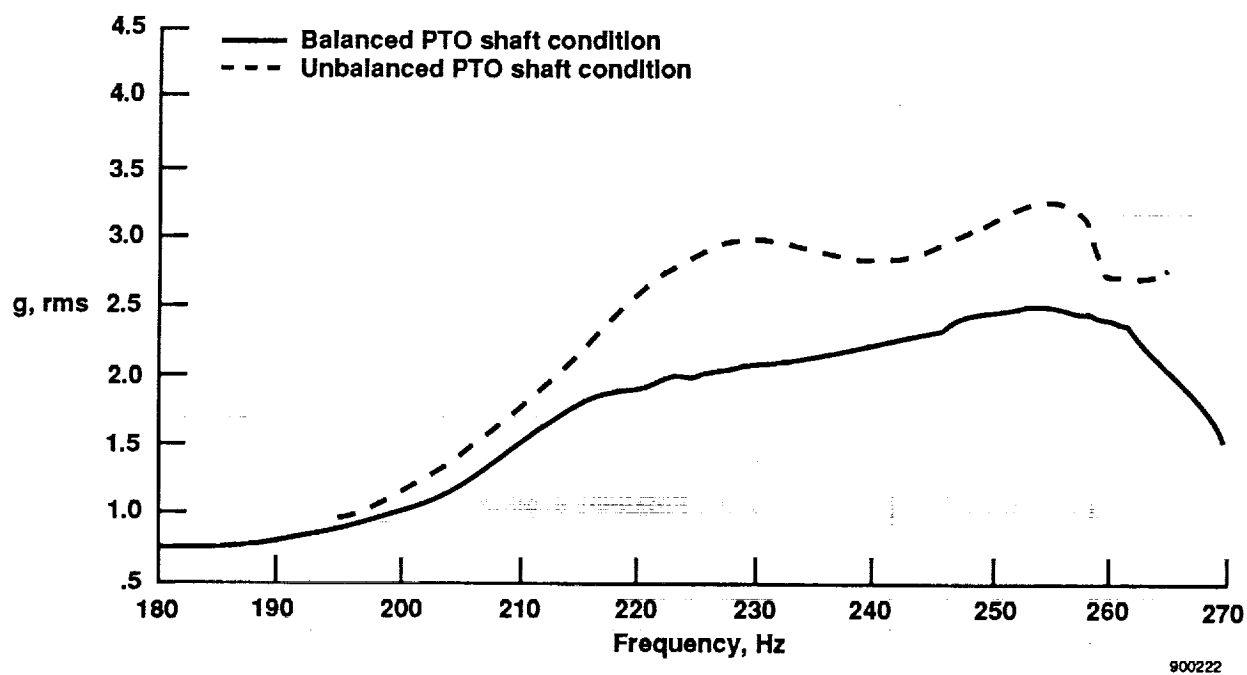
Figure 4. Effect of an unbalance on PTO shaft vibration levels.

During the initial evaluation of the PTO shaft, engine runs were performed with the PTO shaft in both a balanced condition and in an out-of-balance condition. These tests determined the effect of a known shaft unbalance on the gearbox vibration levels. In figure 4, the unbalance increased the vibration levels throughout the operating rpm range.

The real-time flight test monitoring of the PTO shaft vibration characteristics was the main method used to assess the vibration levels of the shaft. The monitoring used the same equipment and methods of the engine ground runs. Vibration levels were measured using the accelerometers located on the AMAD and engine gearbox during flight throughout the operating speed range of the PTO shaft. Using a strip chart and a spectrum analyzer, the vibration levels were determined, tabulated, and compared with nominal balanced data (fig. 4) to determine PTO shaft performance.

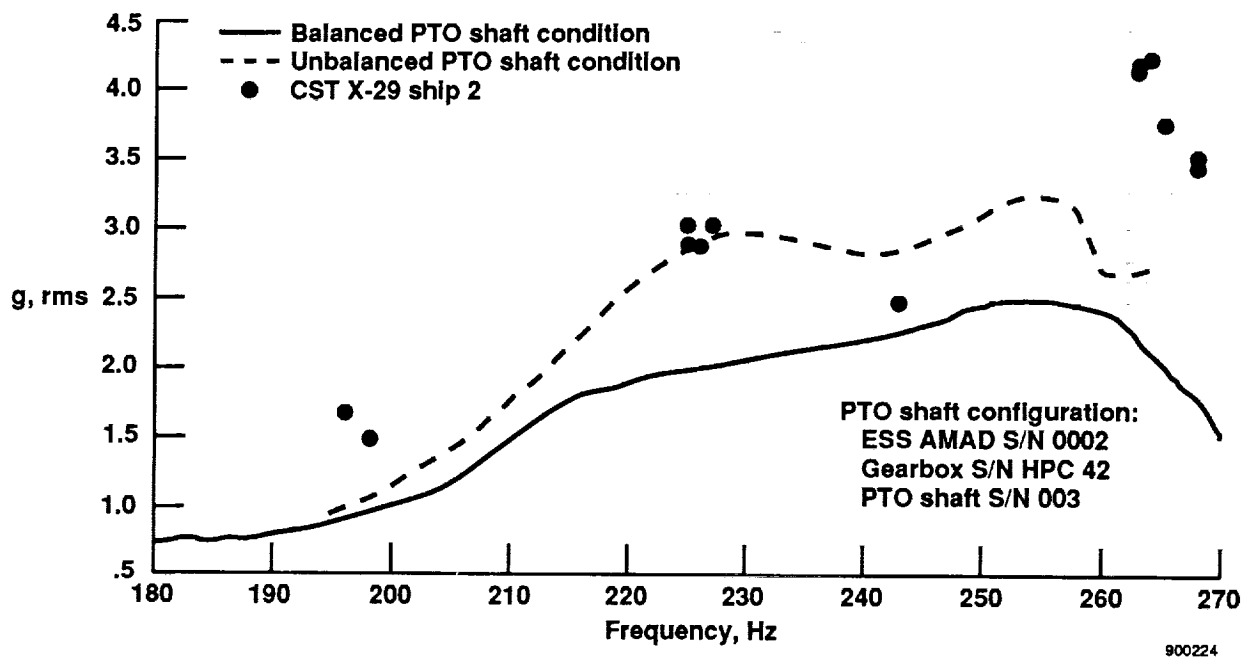
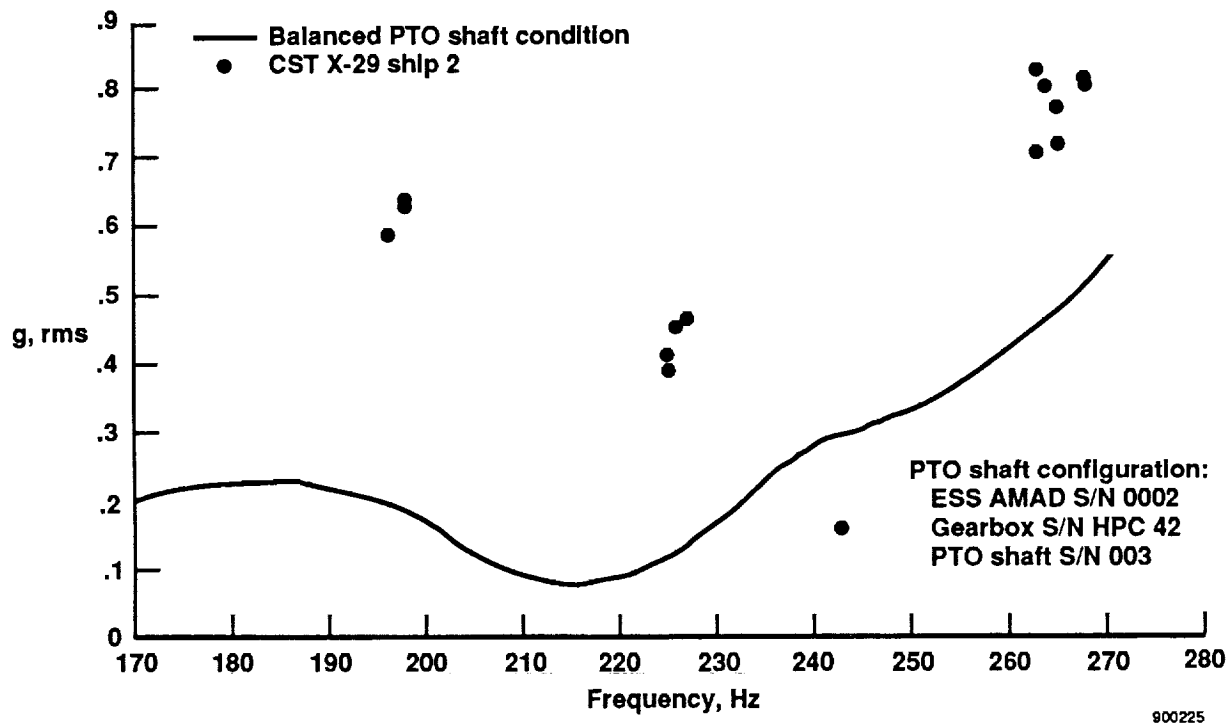
Figure 6. Combined systems test gearbox acceleration data.

Figure 7. Combined systems test AMAD acceleration data.

During the course of the X-29A program, a complete check of all systems including instrumentation, aircraft, and control room operation was conducted. This complete check is called a combined systems test (CST). The gearbox and AMAD data compiled for the second X-29A aircraft during its initial CST are shown in figures 6 and 7. The higher acceleration levels of the gearbox and AMAD indicate an unbalanced shaft installation.

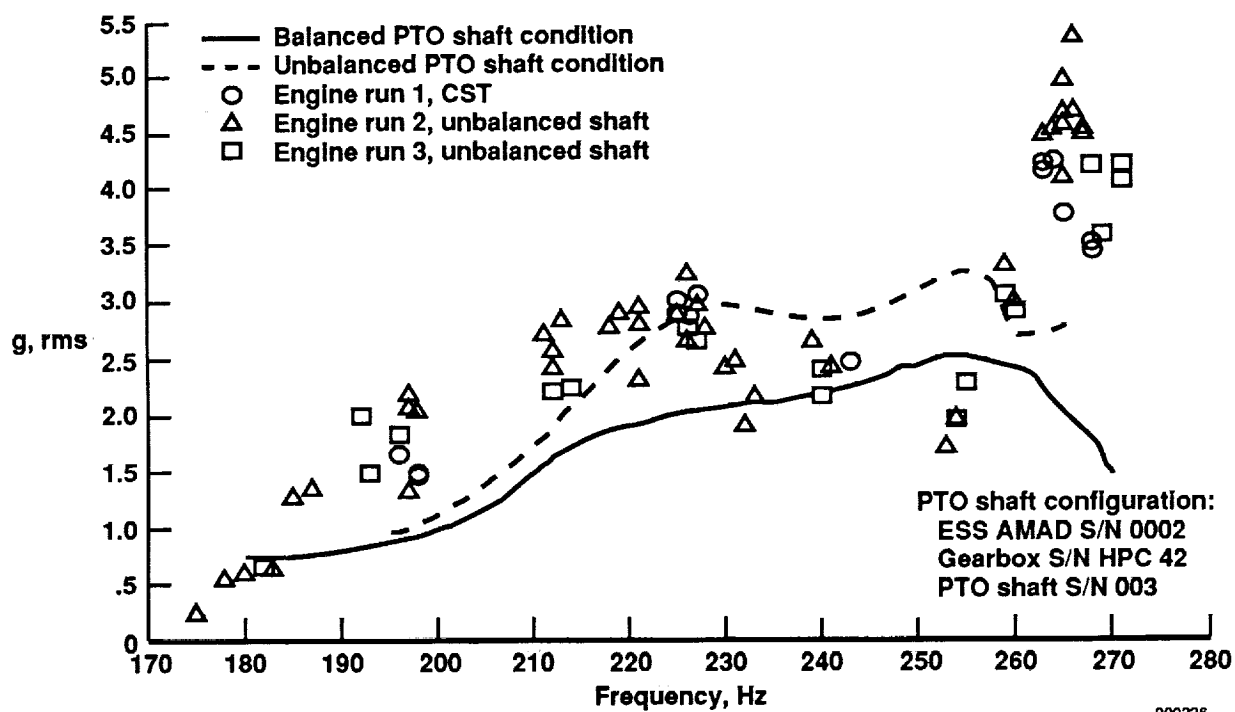
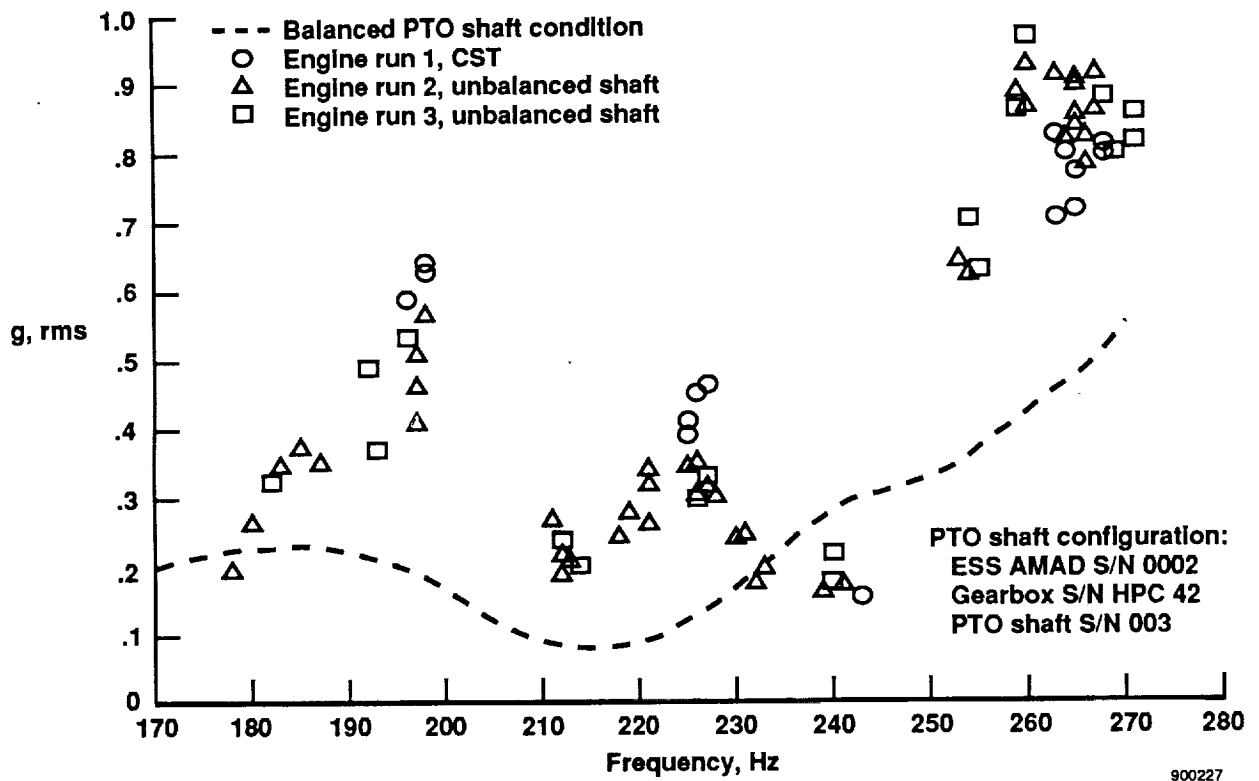
Figure 8. Gearbox engine run data during unbalanced shaft installation.

Figure 9. AMAD engine run data during unbalanced shaft installation.

Several ground runs were performed to troubleshoot the unbalanced PTO shaft. Figures 8 and 9 show the data for three of the engine runs along with the configuration of AMAD, gearbox, and the PTO shaft that was installed during the runs. The first run, the CST, was where the higher vibration levels were first seen. The second engine run was done after a complete check of all the PTO shaft accelerometers and the parameter setup in the control room for any anomalies. After the check, the data were found to be repeated with no significant decrease in the acceleration levels. A more detailed study of the installation procedure found that the PTO shaft was rotated 90° from the correct markings on the shaft. After the shaft was rotated correctly, another engine run was performed. The data showed no major reduction in vibration levels.

The data in figures 9, 12, and 13 show that as the frequency of the PTO shaft approached 200 Hz, the amplitude of the vibration increases. The AMAD strip chart trace in figure 14 shows that the signal from the AMAD accelerometer resembles a sine wave with a calculated frequency of approximately 0.40 Hz. This frequency was termed the beat frequency or frequency difference of two closely spaced modes of vibration. The second trace in figure 14 shows the engine speed in percent of the maximum speed. Interestingly, as the engine speed approached approximately 71 percent or 200 Hz, the amplitude of the beat increases confirmed the plotted acceleration data.

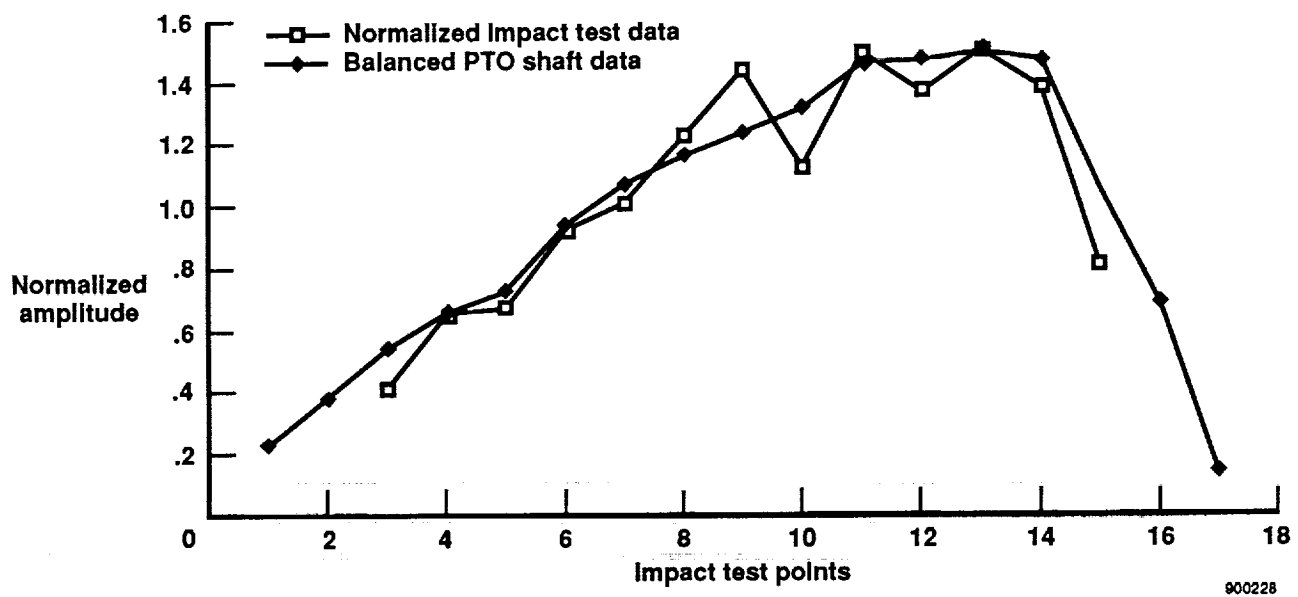
Figure 10. PTO shaft mode shapes comparison.

A shaft GVT was then performed to verify the structural integrity of the PTO shaft. The GVT test of the installed shaft measured the frequency of the PTO shaft mode and compared the data with previously measured data of a balanced PTO shaft. From the response signatures, the vertical and lateral mode frequencies were found to be 362 Hz and 353 Hz, respectively. Both responses are above the design criteria of 300 Hz. The normalized mode shape for the vertical mode is shown in figure 10 along with the mode shape from a known balanced PTO shaft. The data obtained from the GVT closely follow the mode shape of the balanced shaft. The GVT data indicate that the PTO shaft was not damaged and that a problem exists in the installation, or that the shaft assembly itself was unbalanced.

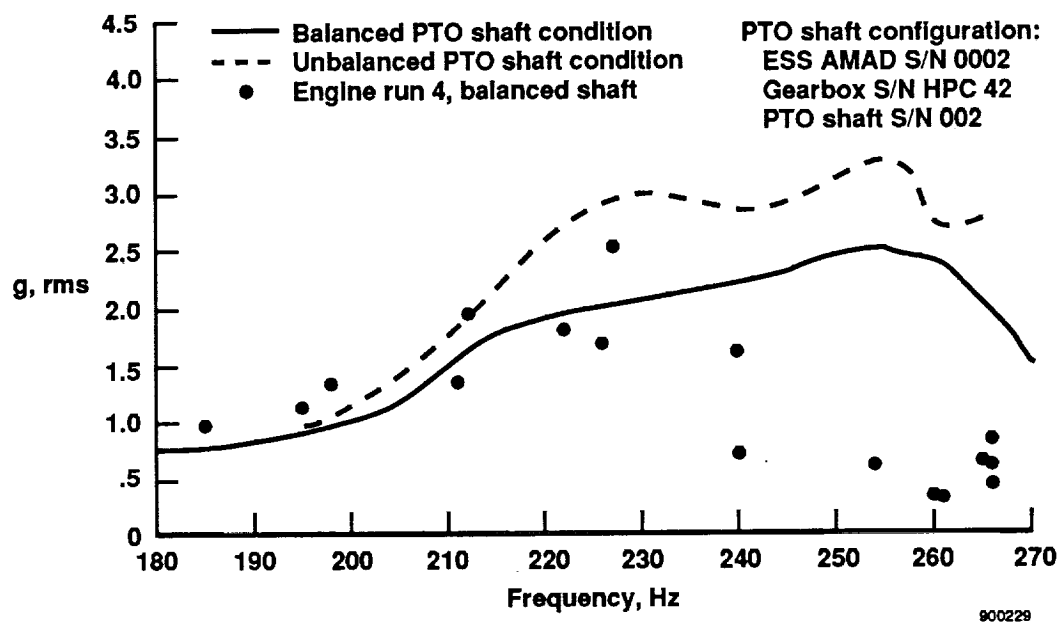
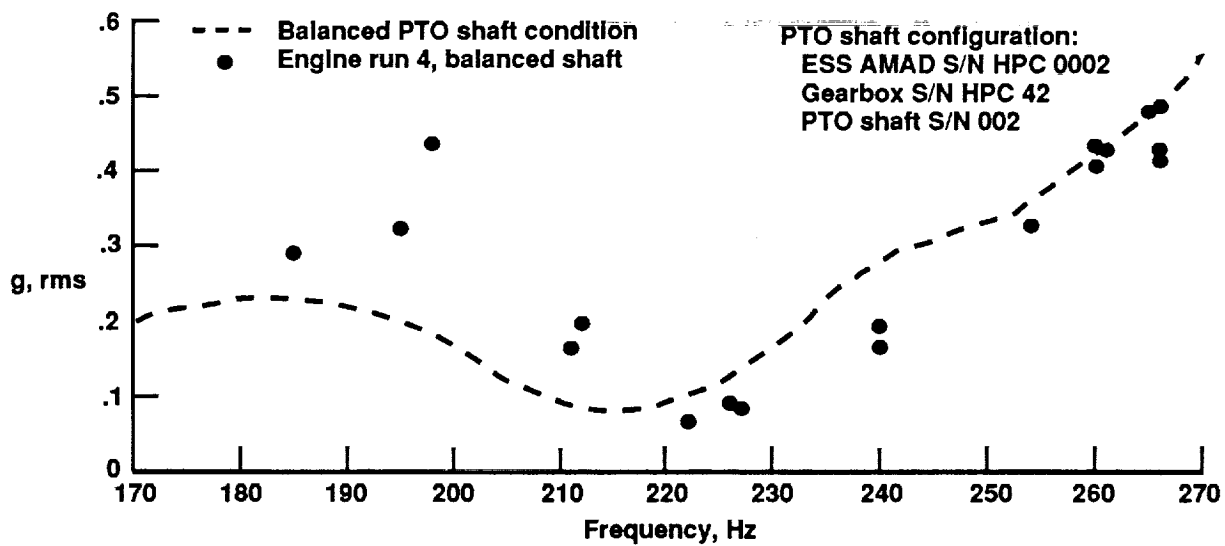
Figure 11. Gearbox engine run data after PTO shaft change.

Figure 12. AMAD engine run data after PTO shaft change.

In lieu of rebalancing the current configuration (PTO shaft S/N 003, gearbox S/N HPC 42, and AMAD S/N 0002), it was decided to change to PTO shaft S/N 002, which had also been balanced with the current gearbox, and AMAD, as shown previously in the table. This PTO shaft was installed on the X-29A aircraft, and another engine run was performed. The data in figures 11 and 12 show a reduction in the vibration levels of the gearbox and AMAD, respectively. The reduction in vibration levels indicates that the configuration was installed correctly and was balanced.

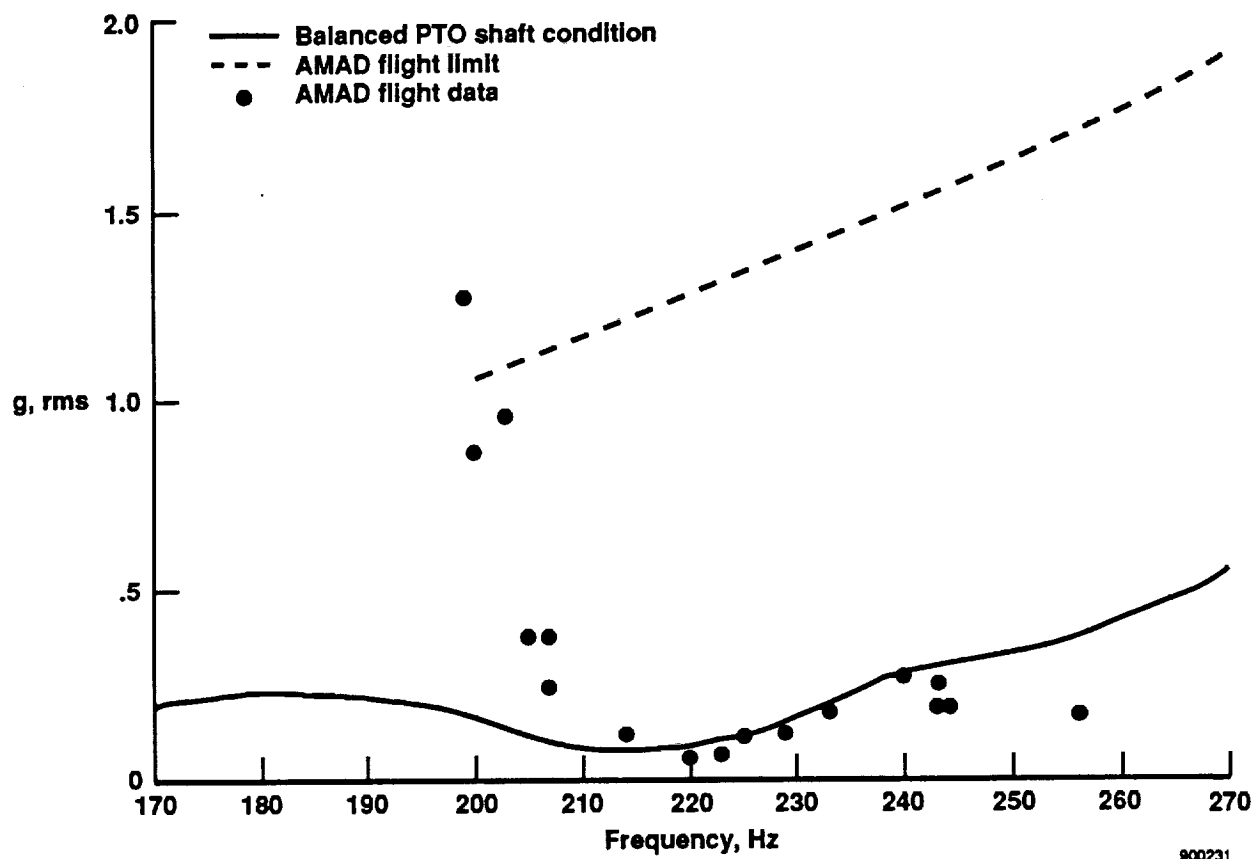
Figure 13. The X-29A AMAD vibration data, ship 2, flight 1.

The AMAD vibration limit was exceeded during the initial flight of the second X-29A aircraft. This occurred at approximately 199 Hz, which corresponds to an engine speed of just under 12,000 rpm or a frequency of 200 Hz (fig. 13). At frequencies above 200 Hz, the AMAD vibration levels were within the established limits. The gearbox data showed no unusual trends and did not exceed any limits. The data indicated that the PTO shaft was balanced and that another unbalance existed in the AMAD.

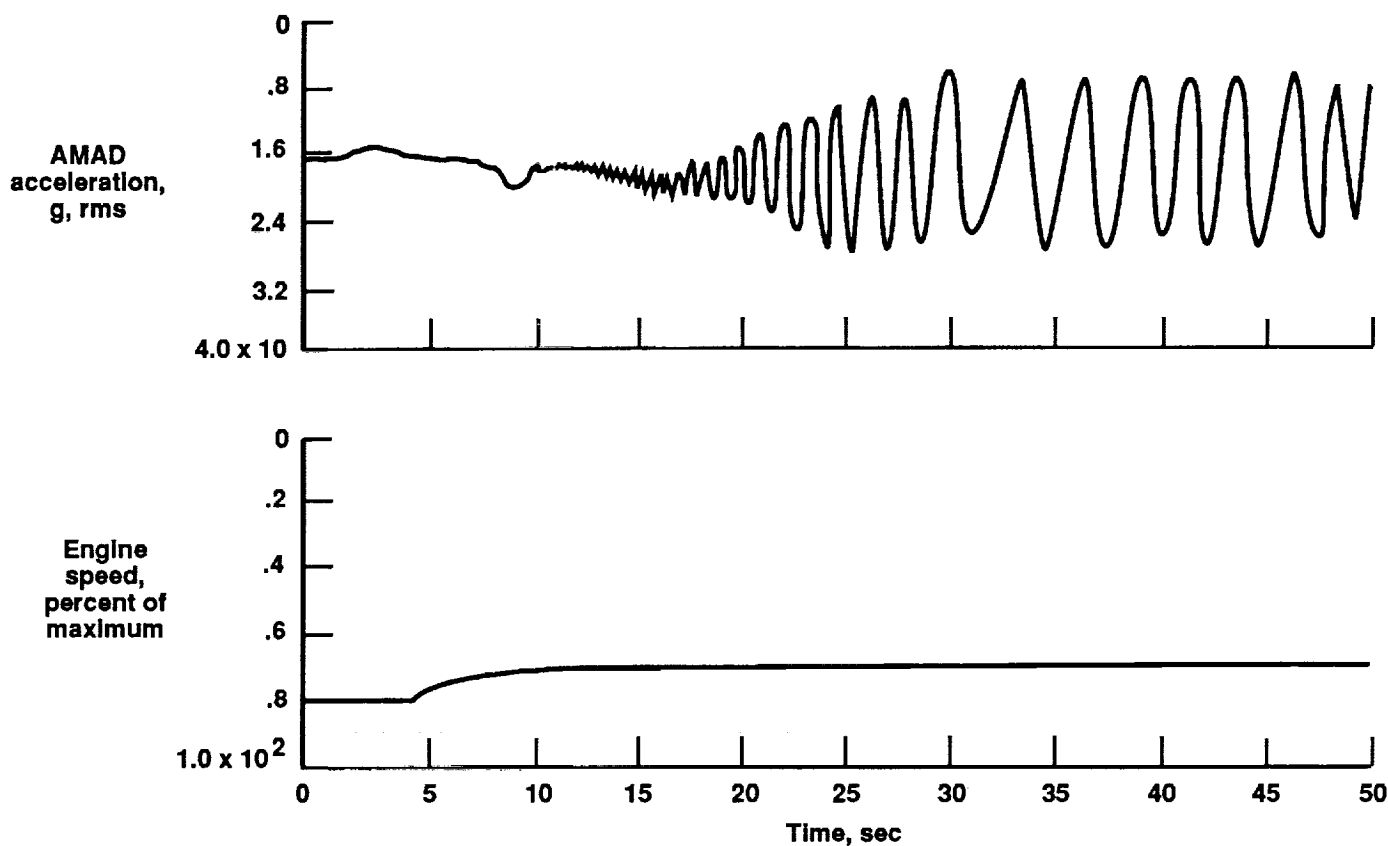
Figure 14. AI IAD vibration and engine speed time history.

As the engine speed trace in figure 14 confirms, the higher AMAD vibration levels occur when the engine compressor speed is in the range of 71 percent of the maximum operating speed of 16,810 rpm, the flight idle speed of the X-29A aircraft. Figure 16 shows that a high vibration level could only occur below 10,000 ft and Mach 0.6. These conditions would most likely occur during the takeoff and landing of the X-29A aircraft.

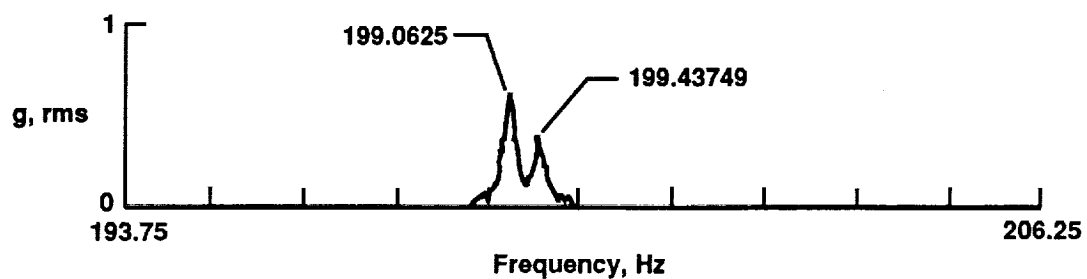
Figure 15 AMAD accelerometer power spectrum.

The power spectrum of the AMAD accelerometer in figure 15 zoomed in at approximately 200 Hz, confirming the presence of two closely spaced modes. The frequency difference calculated from the power spectrums indicated about the same frequency difference as the strip chart trace.

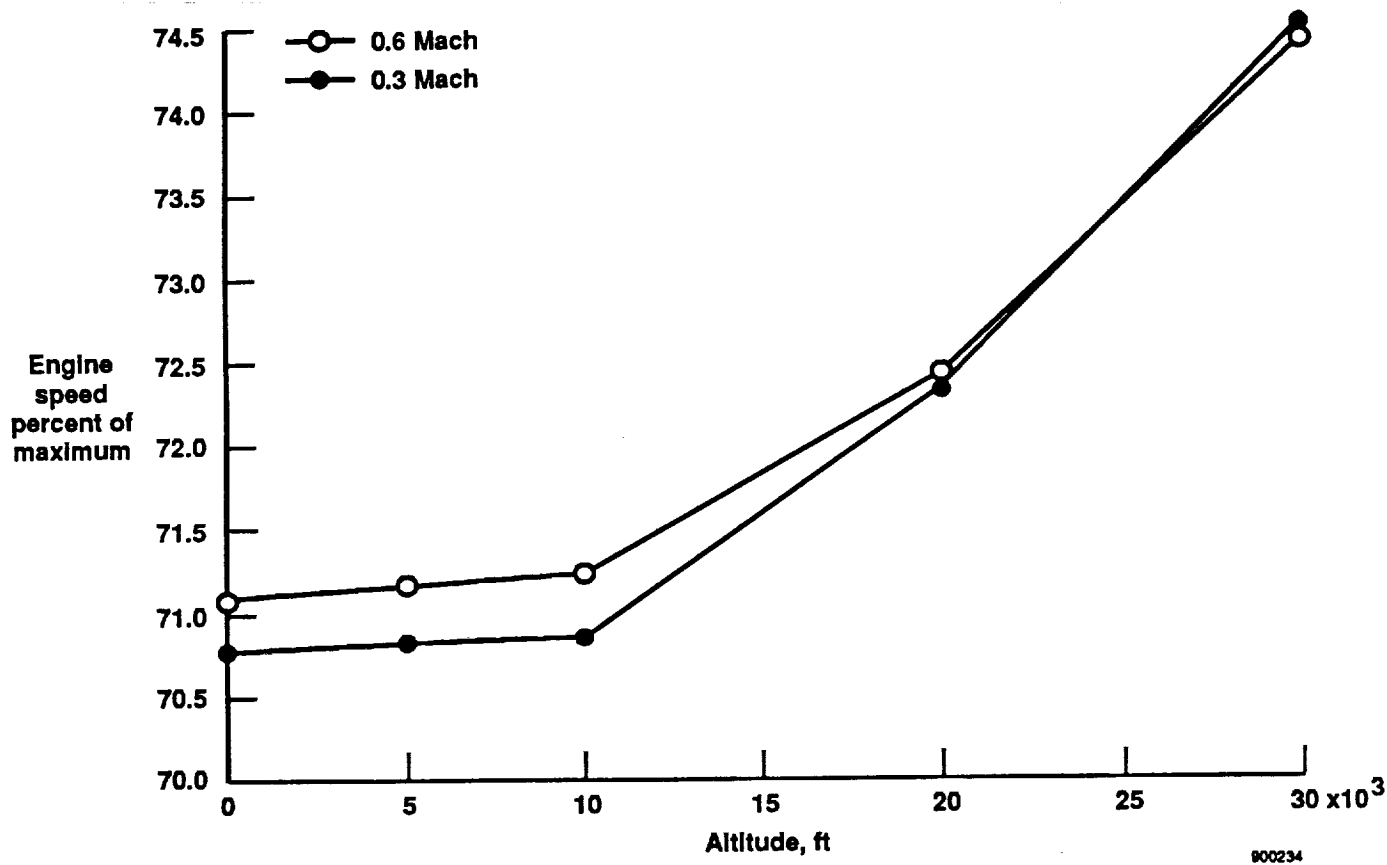
Figure 16. Engine speed variation.
